BCC Reader Evaluation

Version 0.3

February 14, 2008

Prepared for: PSMFC

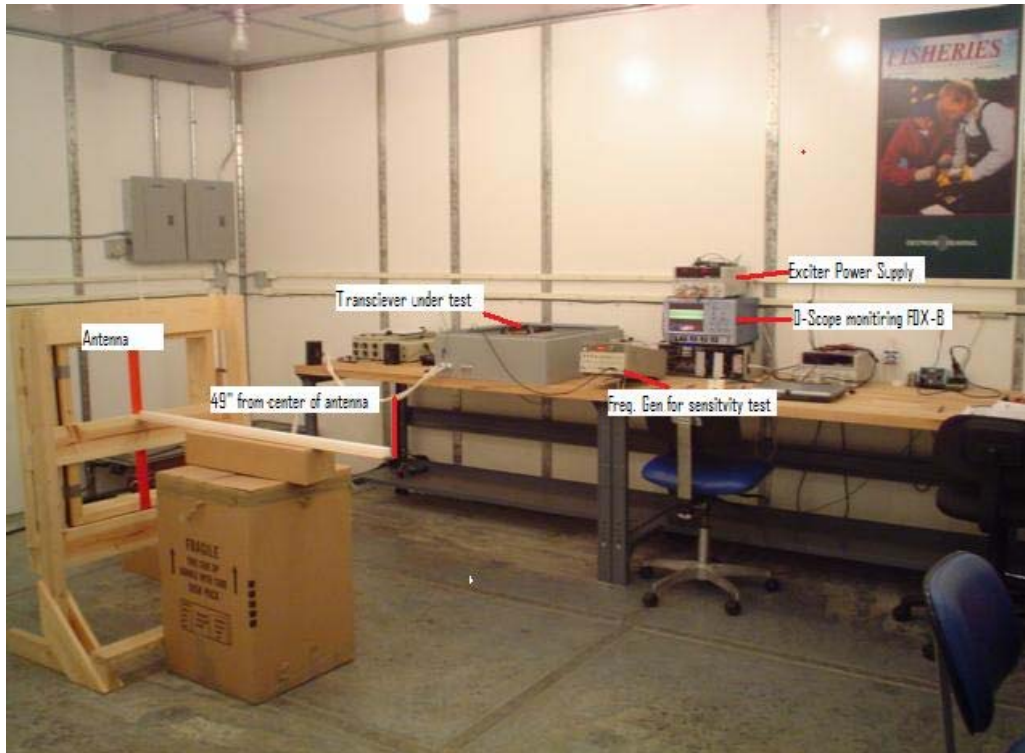
The below picture shows the physical layout of the test facility.

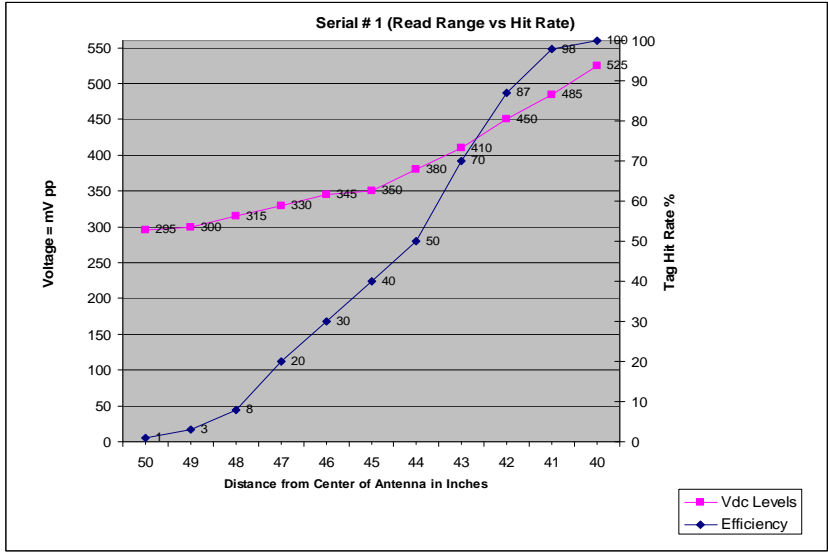
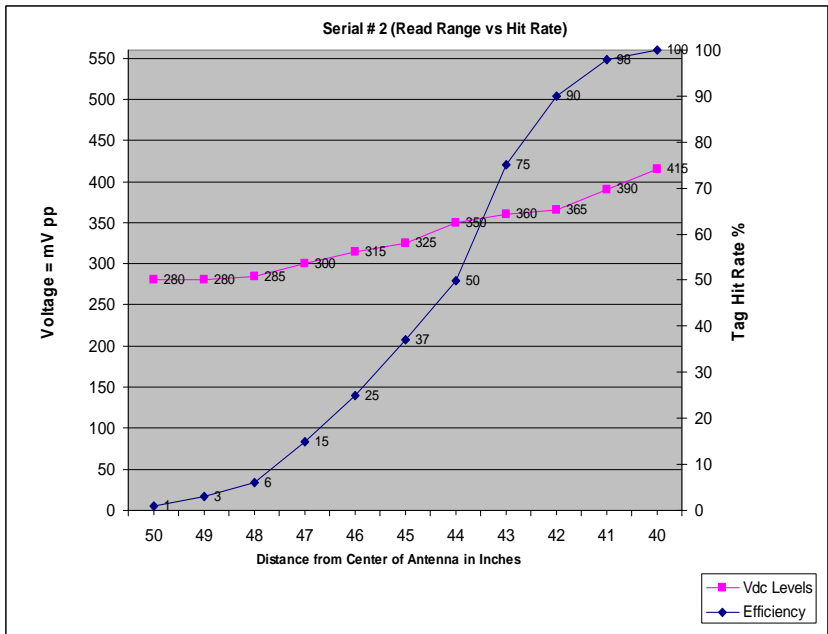
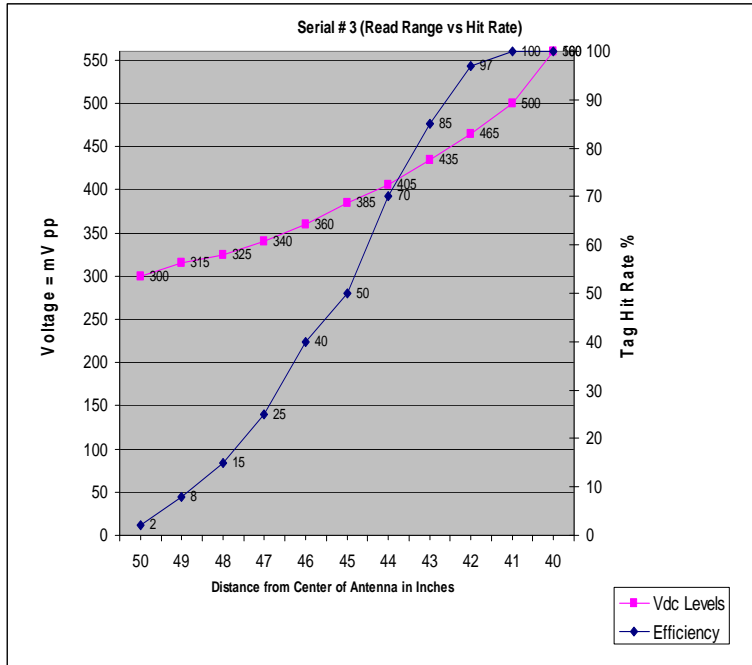
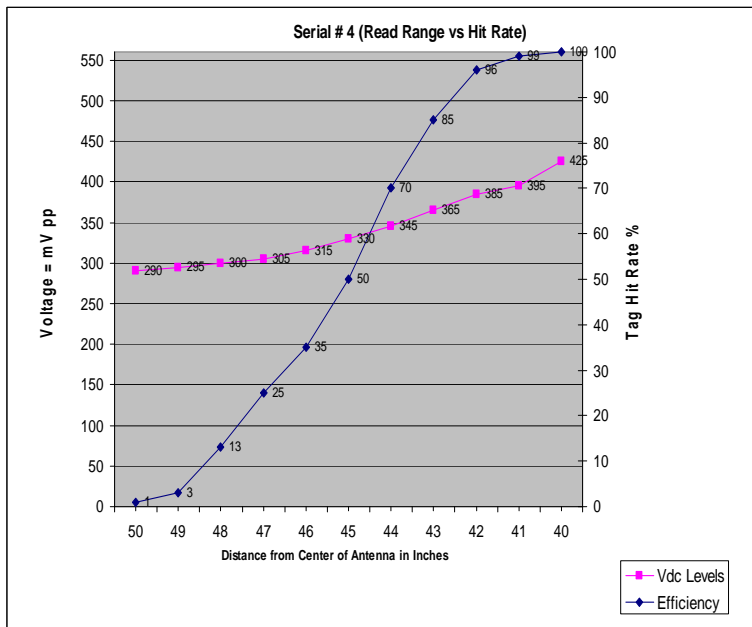
1.1.7 Read Range Test Results for each transceiver.

Below graphs plot Hit Rates Vs Distance from center of antenna Vs FDX-B levels.

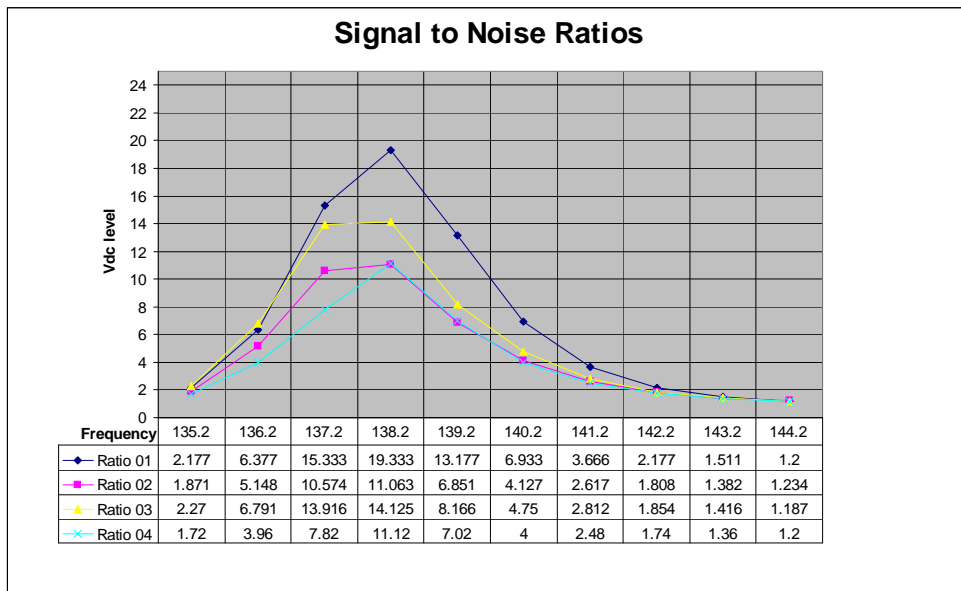
1.1.8 Receiver Sensitivity Test Plots

The following graph shows the Signal to Noise Ratios of each receiver.
